Chapter 4 - Rochester's Constructed Water Bodies

Silver Lake Reservoir

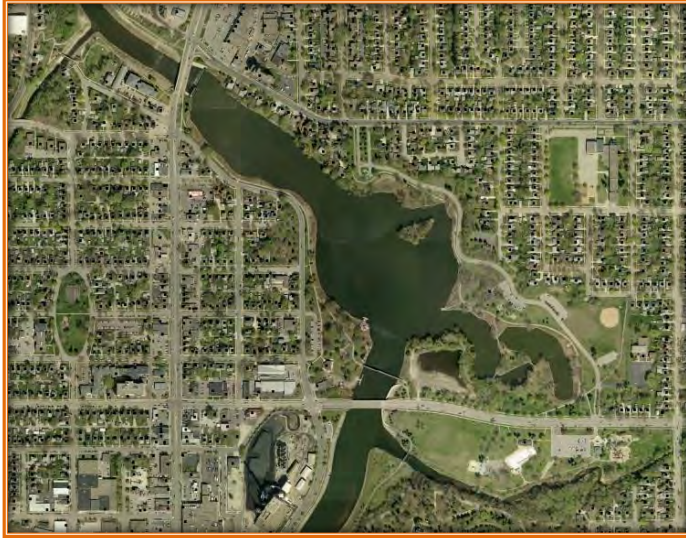
Aerial Photo of Silver Lake 2012

Compare the aerial photograph of Silver Lake today with this 1923 soil survey map of Rochester. Can you see that today's east lagoons were once the Silver Creek channel? A new confluence of Silver Creek with the Zumbro River was another result of the Silver Lake project.

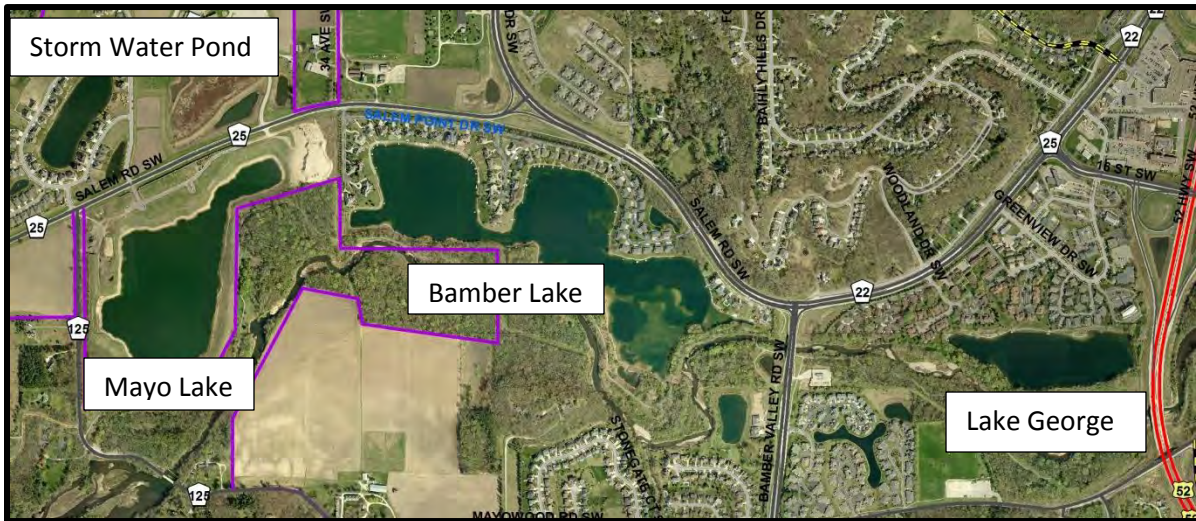
Lakes and Ponds Along Salem Road SW, Rochester

Other mining pits have also been converted to private water bodies that are used for recreation, for aesthetics, or to treat storm water. Bamber Valley Lake, for example, is a small, private lake owned by the Salem Sound and Salem Point housing developments.

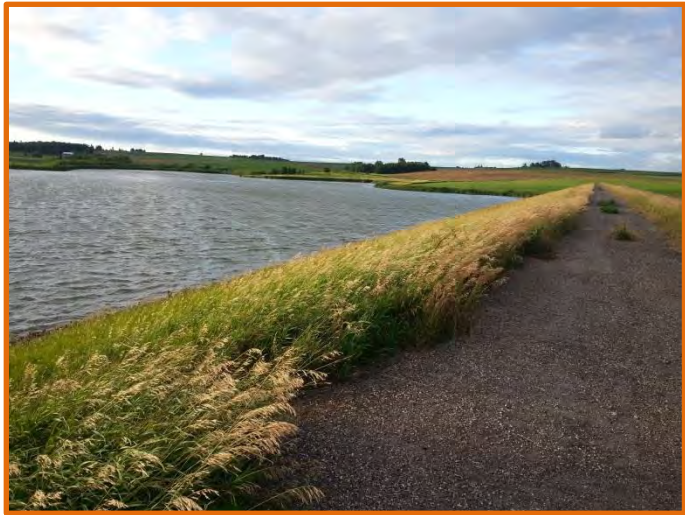
Kalmar Reservoir and Dam

The North Branch of Cascade Creek discharges from KR-7 to the channel below the dam. The water flow is regulated through an engineered control structure.

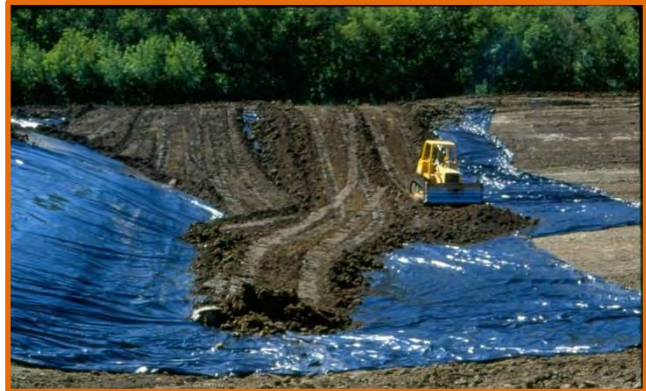
1978 Pond

Quarry Hill Park and Nature Center are located near Silver Creek in SE Rochester. An artificial pond was constructed in the Park in 1978 as an environmental education feature. That pond was built using a plastic liner that was covered with soil. The million gallon pond was initially filled with water pumped from nearby Silver Creek. It was completed on October 12, 1979. Thereafter, water from the Nature Center was pumped into the pond to offset evaporation and to add oxygen to the pond. Unfortunately, the liner was ripped at the time of construction and burrowing animals caused other leaks that added to the problem of keeping water in the pond.

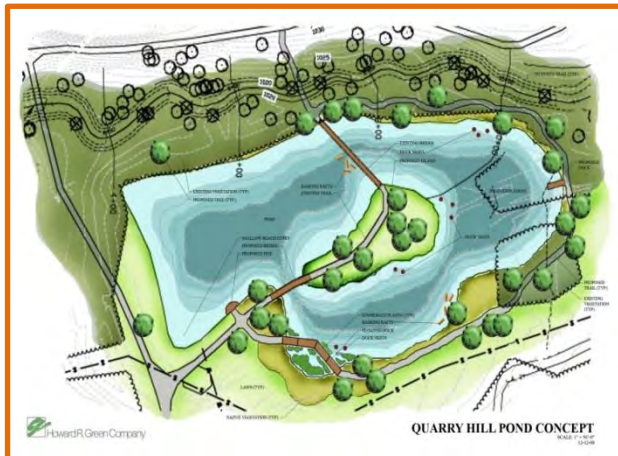
2010 Pond Reconstruction

In 2010, the City got a grant to reconstruct and expand the pond. This time, clay excavated on site was compacted to form the pond liner. Additionally, when Quarry Hill Creek was returned to its original alignment west of the pond, an infiltration system was installed that allowed water to flow from the creek into the pond. An overflow structure was built in the pond to allow high water to flow from the pond into the creek so a more constant water level could be maintained in the pond. In addition to offsetting evaporation, the periodic influxes of creek water also add oxygen to the pond so that well water no longer needs to be used to maintain the pond's water level. By using creek water instead of well water, the Nature Center is also saving money on their water and electrical bills. The DNR stocked the pond with 324 adult bluegill sunfish in 2012.

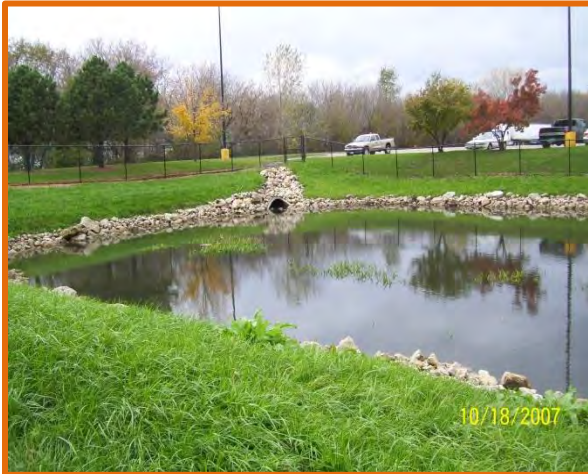
Storm Water Pond

There are other types of constructed water bodies in Rochester, too. Some developments build a pond solely as a feature to beautify their landscape. There are hundreds of ponds built to manage storm water (see Ch. 7 Rochester's Storm Water Management System). Rochester was responsible for building the dam that created Lake Zumbro (another reservoir) to produce hydroelectric power. To meet floodplain regulations, some ponds are built to provide flood storage when it is lost because of construction in the floodplain. On golf courses, ponds are built to provide a challenge to golfers. It is difficult to

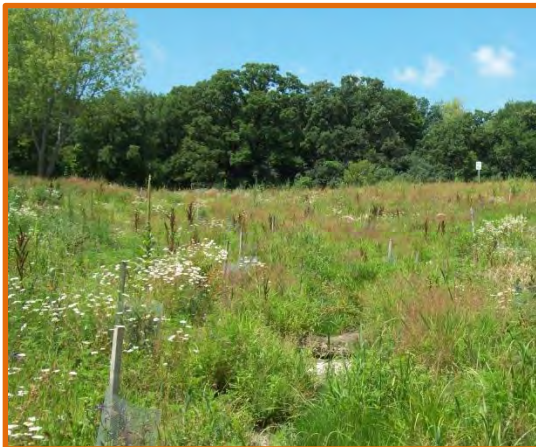
Restored Wetland

Throughout Rochester, there are many acres of constructed wetlands built to offset wetlands that are lost when new residential and commercial areas are constructed. Constructed wetlands must be created to meet the requirements of the Minnesota's Wetland Conservation Act (see Ch. 4 Rochester's Natural Water Features). A new technique being tried in Rochester today is the installation of floating wetlands to help absorb nutrients in storm water ponds.

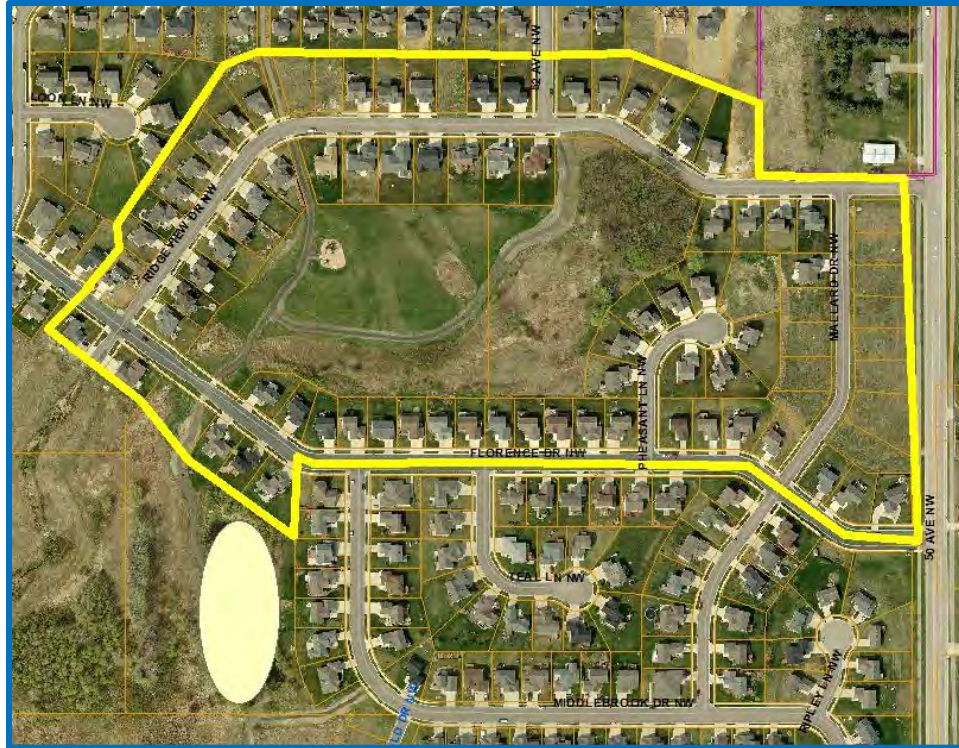
1. a) A wet basin is required to have a permanent pool volume (V_{pp}) of 1,800 cubic feet of storage below the pond’s outlet pipe for each acre that drains to the basin. Ridgeview Manor is a residential development in NW Rochester that contains homes, roads, parkland and wetlands. Assume the yellow line in the following map encompasses a drainage area of 50 acres and all the water within that area will flow to a pond to be located where the yellow oval is placed on the figure below. To treat the drainage from this area, how many cubic feet of storage will be needed below the outlet pipe? (Hint: $1,800 \text{ ft}^3/1 \text{ acre} = V_{pp} \text{ ft}^3/50 \text{ acres.}$)
