Chapter 5 - Rochester's Water Supply

Contamination of Water Supplies in Limestone Formation

By S. P. Kingston

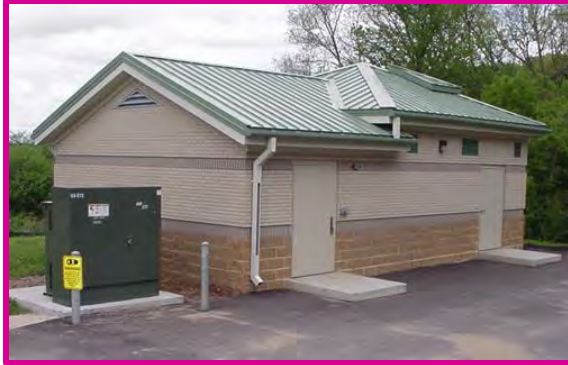
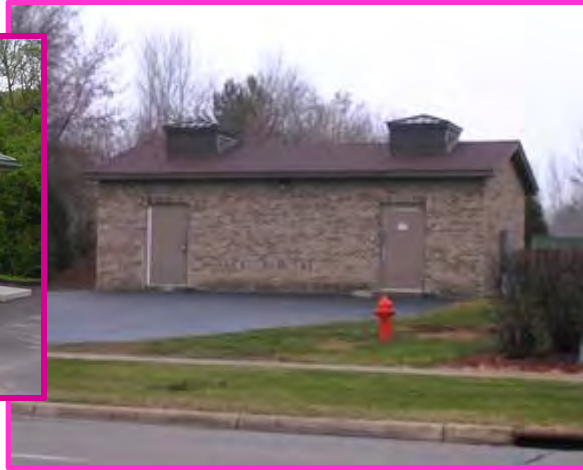
RPU Well Houses

Each well is housed in a building that matches the architecture of the area. The wells are numbered for ease of identification. Each well is continually monitored electronically by a computer system that automatically starts and stops pumping when water usage needs change or when water levels in towers reach different programmed levels. In addition, the computer system monitors the energy usage of the pumps and the water levels of the aquifers.

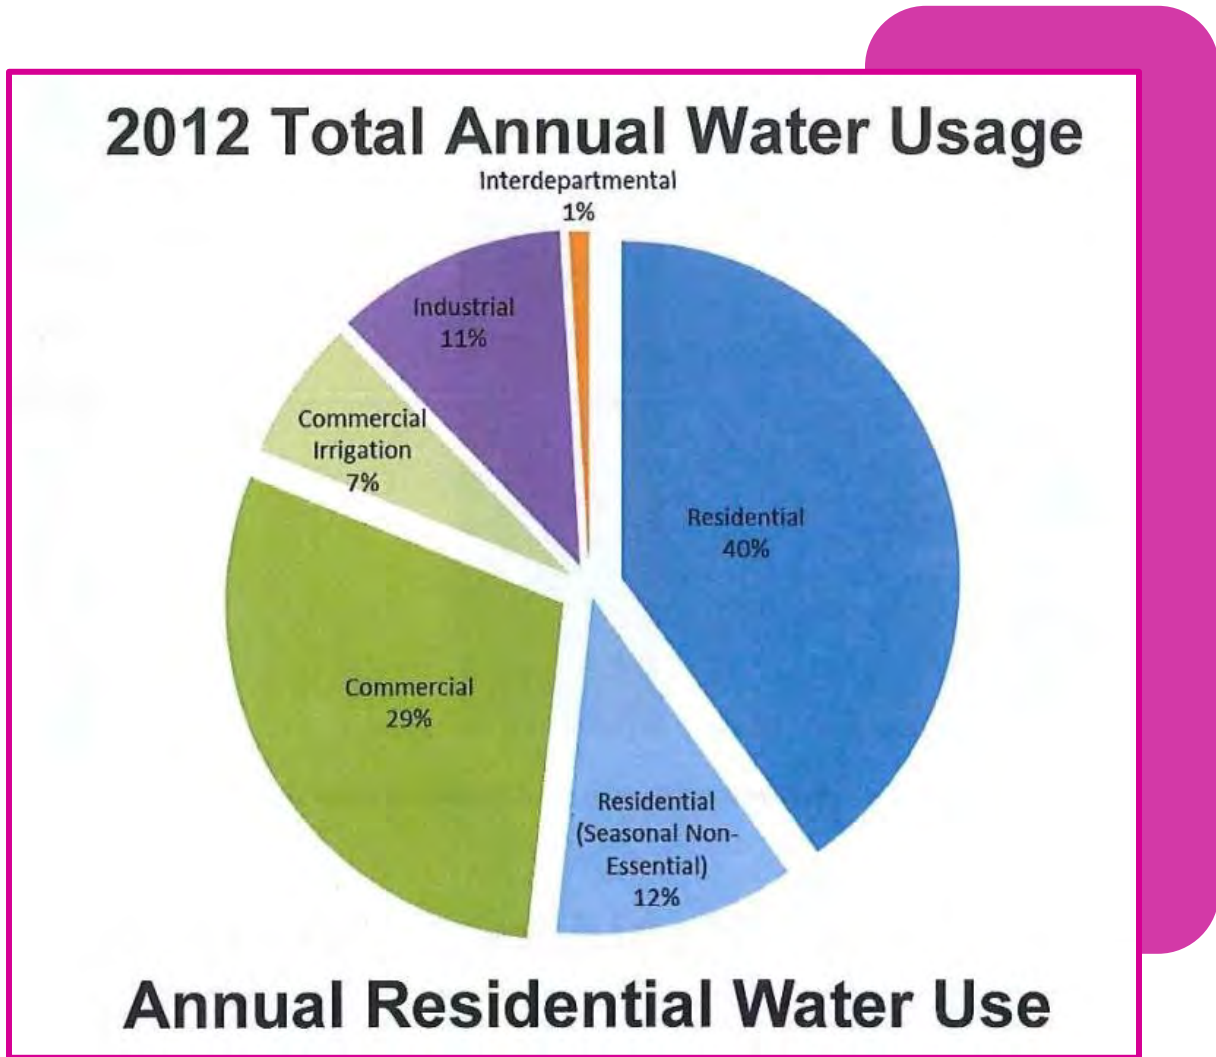
RPU tracks how much water is used by each customer class. In the following chart, industries manufacture goods while commercial companies provide services. The “Residential (Seasonal Non-Essential)” segment is the same as irrigation. The “Interdepartmental” segment is used by RPU. Overall, residential use makes up just over half of the total annual water use in Rochester.

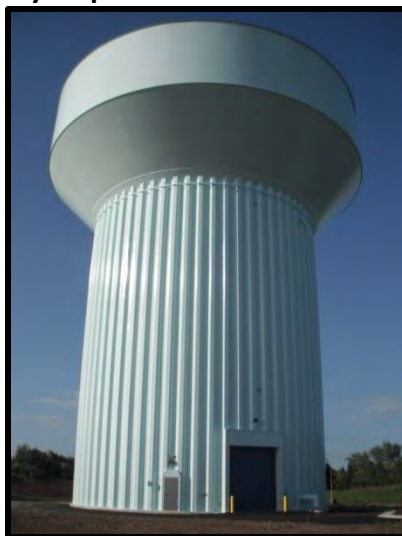
Hydropillar

In addition to the familiar water towers, water storage facilities can take on other forms, such as a standpipe or a hydropillar. In a hydropillar, the top bell is where the water is stored. A maintenance pipe and electric lines usually run through the center. RPU collects a fee from companies that use the towers to support cell phone networks. Water can also be stored in underground reservoirs. Currently, there is a water storage reservoir underneath a parking lot on 4th Street SE, but this is programmed for removal in the near future, when a new water reservoir to serve downtown Rochester is built near St. Mary's Hospital.

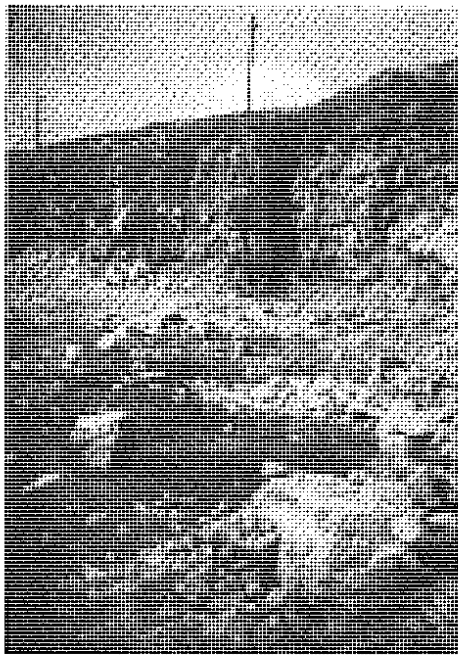
The vertical and horizontal channels of the limestone quarry, indicate how easily contamination can travel great distances in the rock. In many cases contamination can, and has, entered municipal and private water supply systems.

FIG. 3. Limestone Quarry

(5) In an attempt to locate the source of contamination for well "B" fluorescein dye was introduced into an opening in the stone quarry (Figs. 3, 4). The opening had been used as a place of excreta disposal by the quarry employees. Within less than six hours the fluorescein dye appeared in a large spring situated approximately 100 ft. from well "B" and 1600 ft. from the quarry. The spring had been used for a drinking water supply up until the time well "B" was constructed. While
